THIRD SEMIANNUAL REPORT

HIGH TEMPERATURE HYDRAULIC SYSTEM
ACTUATOR SEALS FOR USE IN ADVANCED
SUPERSONIC AIRCRAFT

CONTRACT NAS 3-7264

FAIRCHILD HILLER
Republic Aviation Division
Farmingdale, Long Island, New York

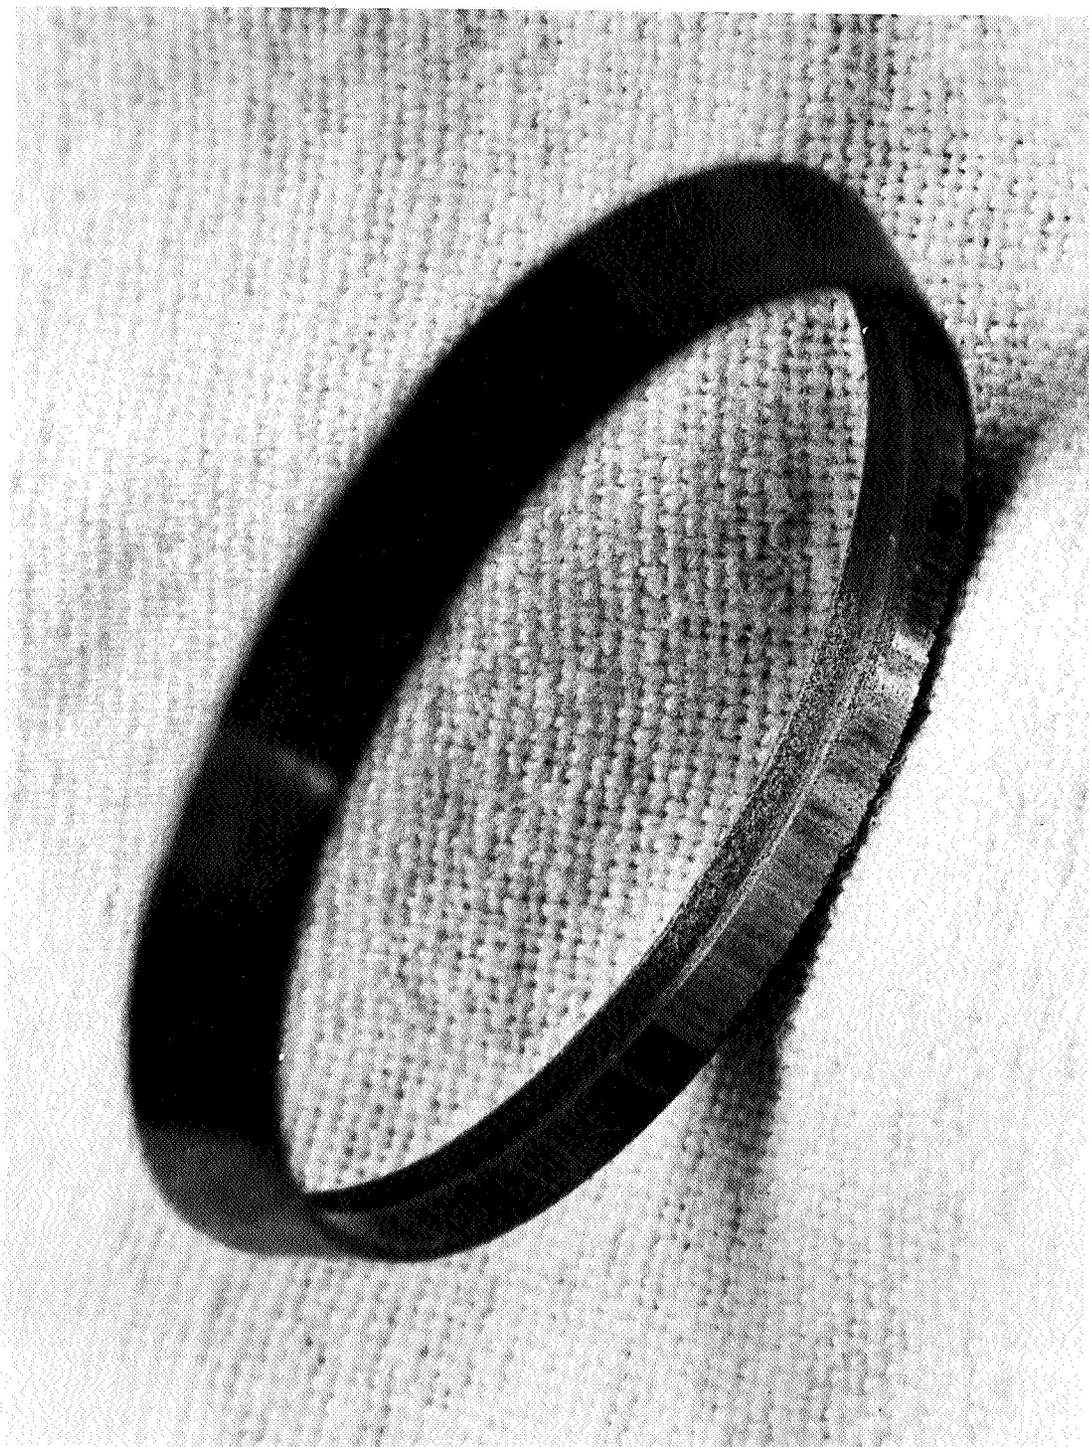
Figure 21. Nickel Foammetal Wedge Seal After Test

that the open pores of the sealing surface were burnished. As shown in Figure 21, a series of longitudinal scratches was noticed on the burnished surface. Inspection of the rod showed similar scratches. However, these scratches were not on the rod during initial assembly. A thin greyish film was also noticed on the piston rod, which appeared to have been transferred from the nickel Foametal. This film was easily rubbed off with fine emery paper. Since the seal friction load showed only a slight decrease at the termination of the test, it was concluded that the seal contact load was not lost. Therefore, the leakage experienced during the test was caused by the numerous leak paths formed by the scratches on the sealing surface of the wedge. Closer inspection revealed that the scratch marks resulted from the pull-out of material at the sealing surface. This condition was due to sliding of the nickel Foametal seal on a transfer film of the same material on the rod. This sliding resulted in welding and subsequent shearing of the material from the sealing surface of the wedge.

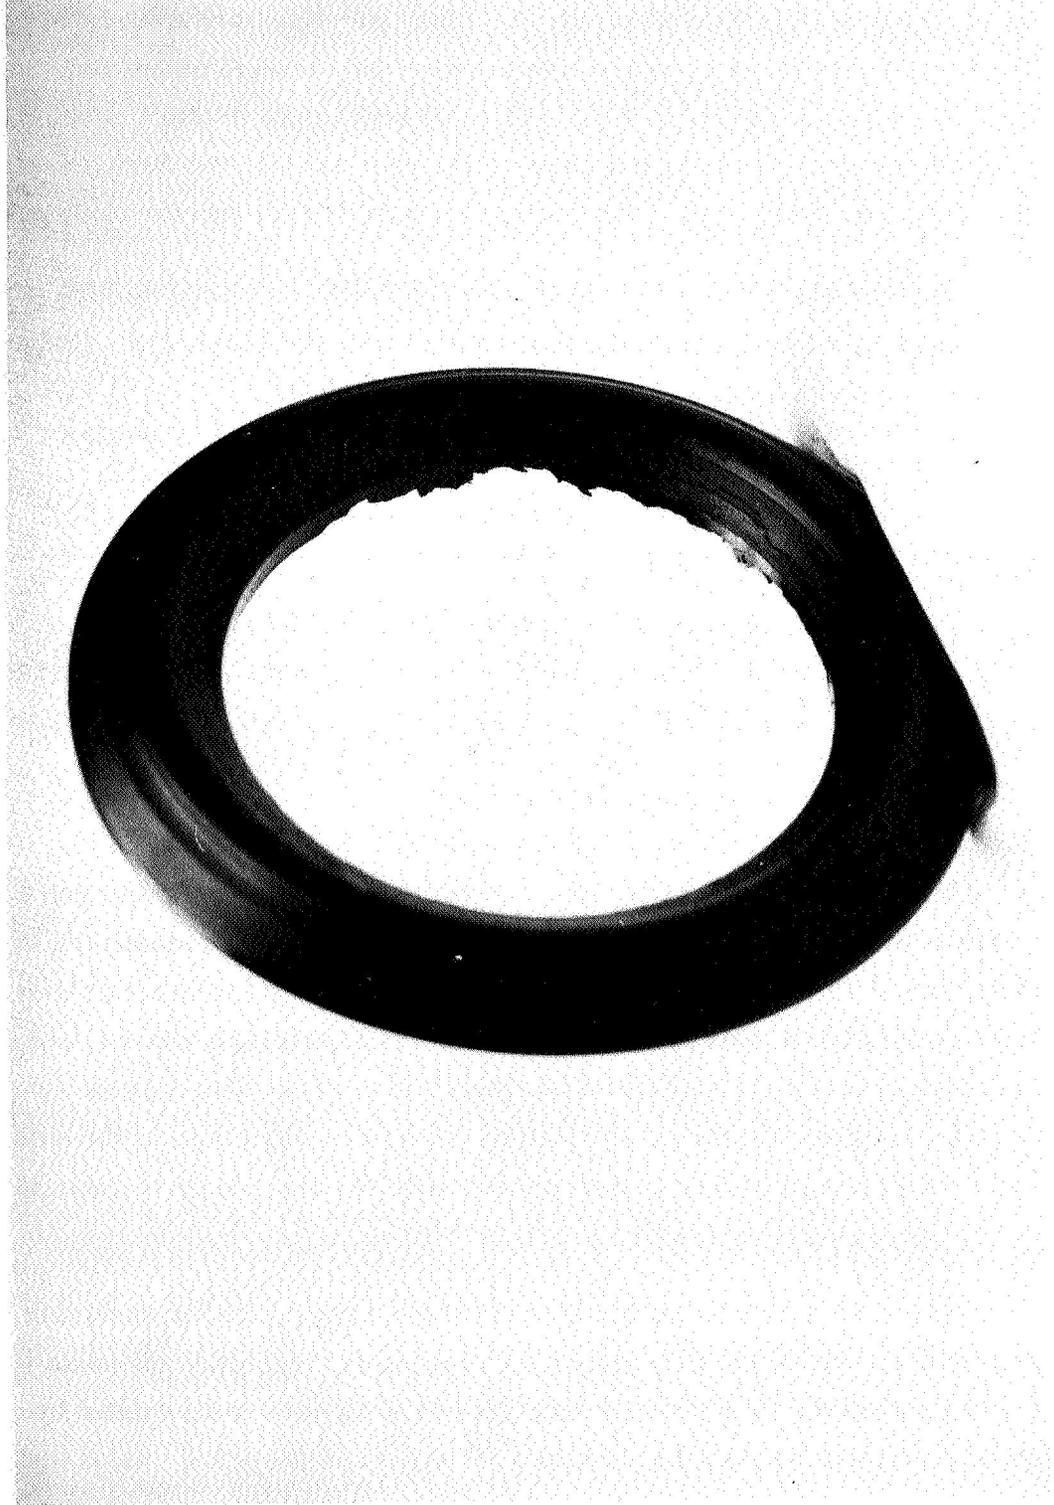
Figure 29. Extrusion of Polymer SP V-Seal - B-End

Inspection of the Polymer SP V-seals showed extrusion of the seal on the B-end of the actuator. The inner lip of the up-stream seal extruded into the clearance space formed by the load ring and piston rod (see Figure 27). This clearance measured approximately 0.014 inch. Although the same clearance gap was present on the A-end, the extrusion experienced by the A-end seal (Figure 28) was negligible. A check of the spring washers indicated that the spring load on the A-end (172 pounds) was less than the design load of 200 pounds; this could account for the minimal extrusion on the A-end. The spring load on the B-end was approximately 209 pounds, which is very close to the design load.

The observations described above showed that, with the exception of extrusion on one of the three sealing elements on the B-end, all seals were in good condition. Excessive leakage at 600°F appears to be caused by differential expansion between the Polymer SP seals and the 440 C piston rod.
